COASTAL BLUFF Geo-Hazard Checklist

Learn to identify coastal bluff erosion and high risk areas of instability on Lake Huron's shoreline

Updated 2020 Lake Huron Centre for Coastal Conservation

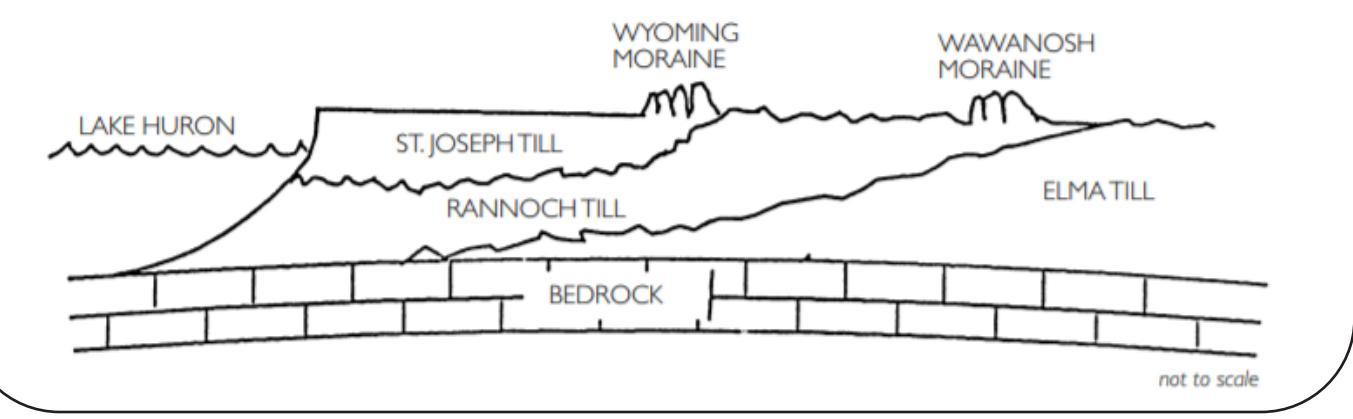
Glaciers towered above and shaped the Great Lakes during the last ice age. Lake Huron's bluffs are composed of glacial till (that's the clay, silt, sand and cobble material left behind by glaciers). The following cross section depicts Lake Huron's various till formations, which are highly prone to erosion.

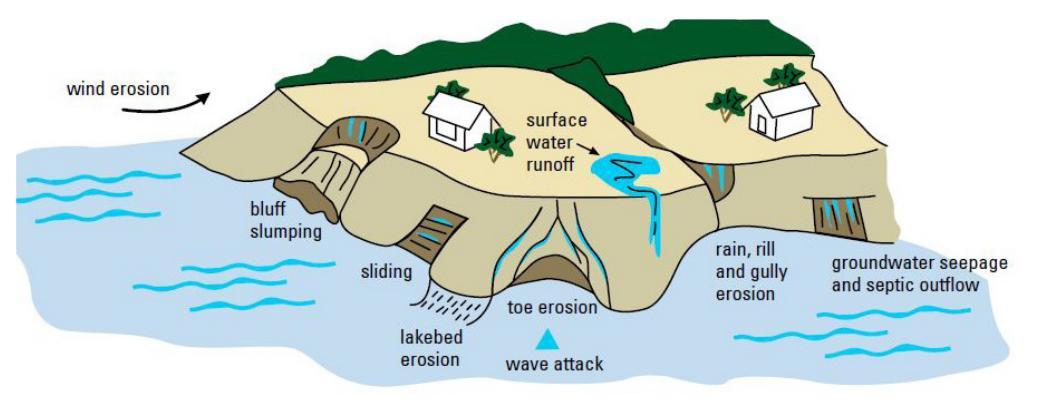
St. Joseph's Till is found in most of the exposed bluffs. Beneath is the stoney Rannoch Till in the shorebluffs, typically separated by a boulder horizon. The Rannoch till, the Bedrock, is extremely resistant to erosion. Portions of the erodible St. Joseph's Till are below the lake water level.

These bluffs are highly prone to erosion. Once the bedrock becomes exposed, it helps to provide long-term stability and restricts further downcutting. In some areas, these bluffs have high recession rates, between 0.5m/yr to 2m/yr depending on the season and section of the bluff.

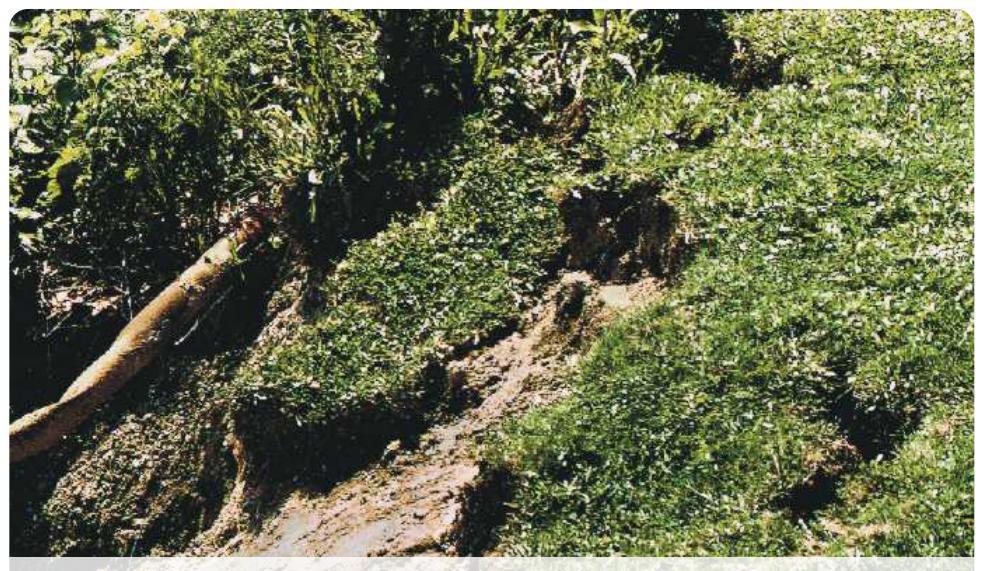
Tension cracks on the ground (Source: Maine Geological Survey, 2015)

Cracks are a sign of instablity within a bluff.

Surface layers of a bluff tend to stretch and develop cracks as a sign of motion and instability within the bluff. These can occur either on top, near the edge of the bluff or on the slope itself; they are long and deep cracks sometimes extending below the layer of soil.

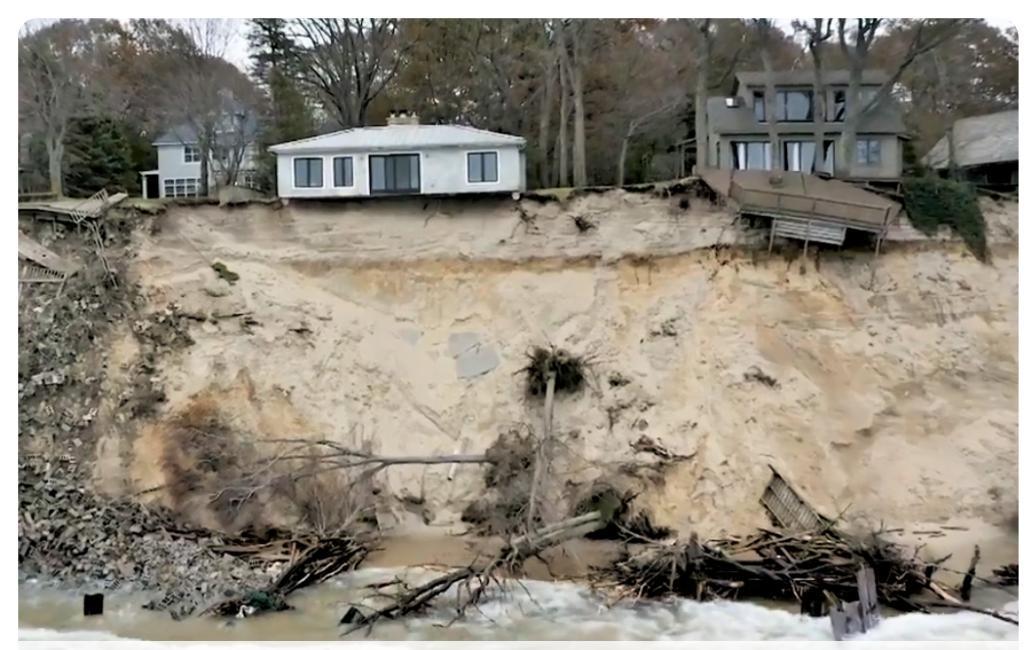
Bluff erosion taking out a house (Source: Great Lakes Now Video Episode)

When a mass of material slides a short distance downward in a concave movement on a bluff or gully slope, it is known as a slump. A slump can occur due to many underlying factors that indicate ground movement.

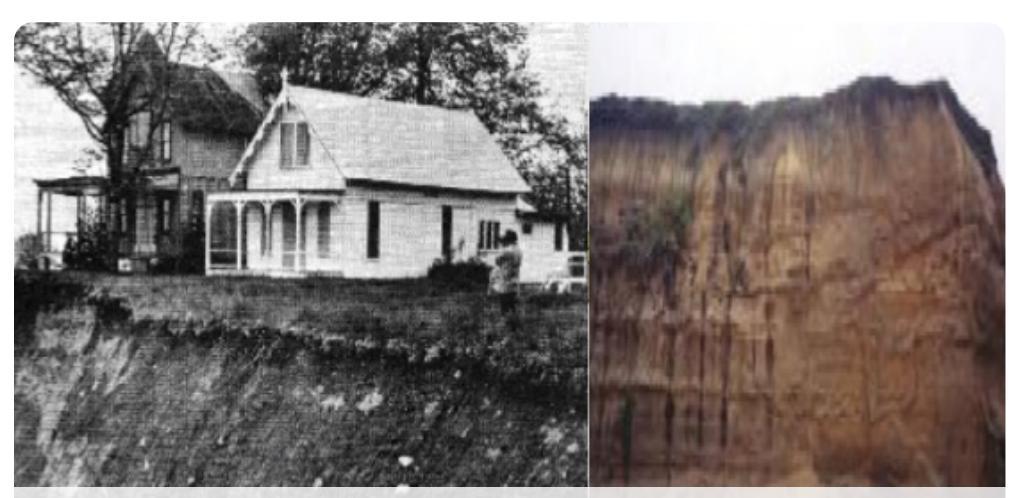
Source: modified from Hampton & Griggs, 2004 and DEPA, U., 2001

Excess groundwater and septic outflow can make bluffs unstable.

Excess groundwater leading to seepage or septic outflow could make a bluff highly unstable. Bluffs are often made up of unsorted materials and when the empty spaces between these are filled with water, the water acts as a lubricant and makes these particles slip away from each other, thereby causing a slope failure. Ground water seepage is pictured below.

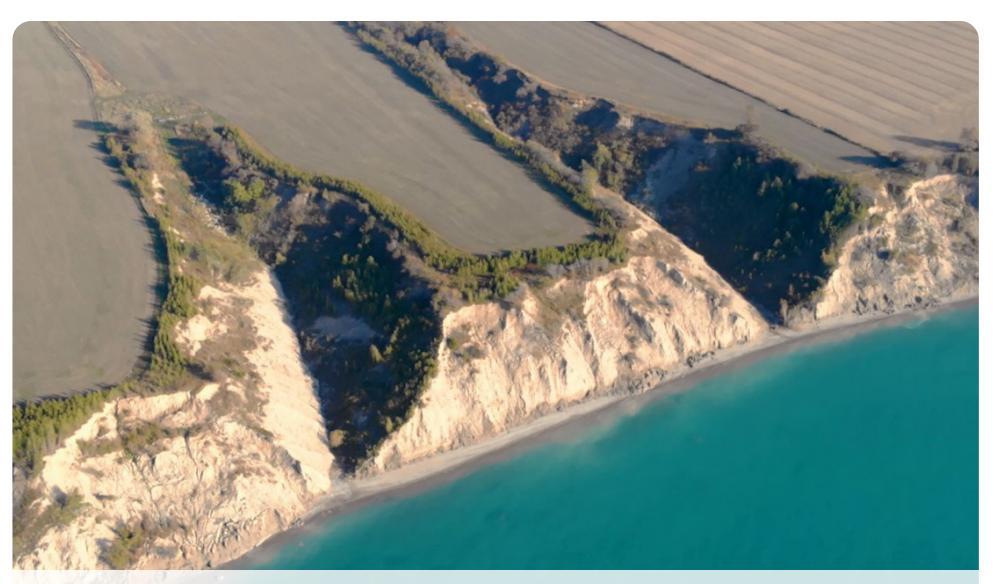
Aerial view of large gullies (Source: modified from The Lake Huron Centre for Coastal Conservation - Gullies, n.d.)

Water from increased drainage from farm fields, urbanized development, rain, and storm events cut into the clay soil of the bluffs; thereby creating gullies. Gullies get wider and deeper with time and are prone to slumps and landslides along their sides that increases the amount of erosion.

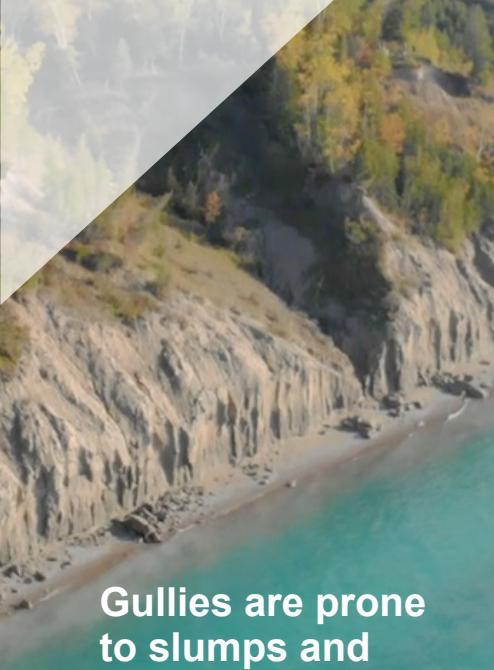
Gullies are prone to slumps and landslides as they get wider and deeper with time.

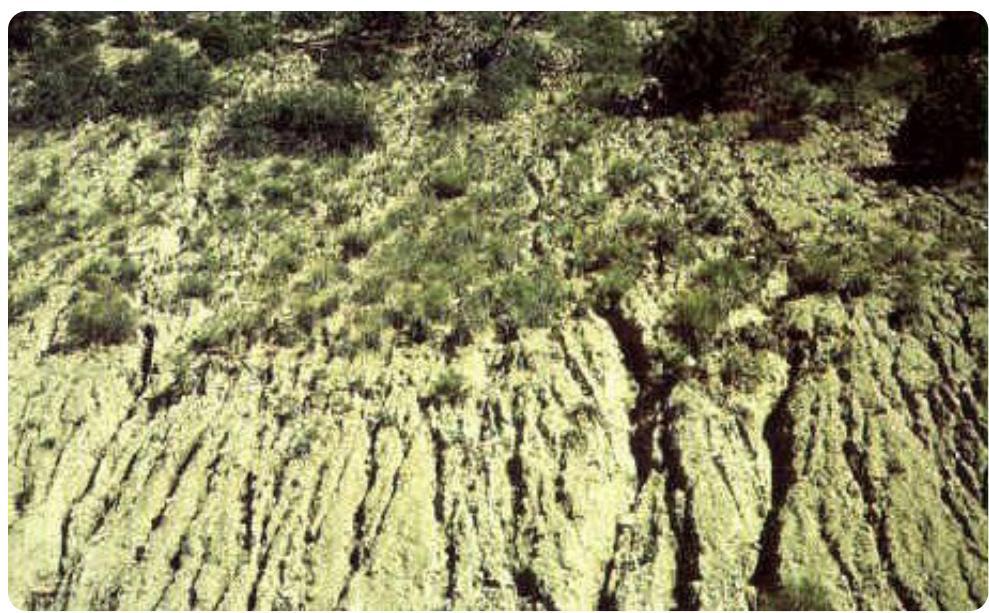
As excess water flows down the bluff, it picks up velocity, causing rills.

Overland flow causing rills. Source: modified from Williams, H., n.d.

When the farms, lawns and gardens, situated on a bluff are watered, or when it rains, the excessive water is left to flow down the slope. As the water flows down the bluff, it picks up velocity and drags along silt and stones with it; thereby creating rills along the face and causing recession of the bluff.

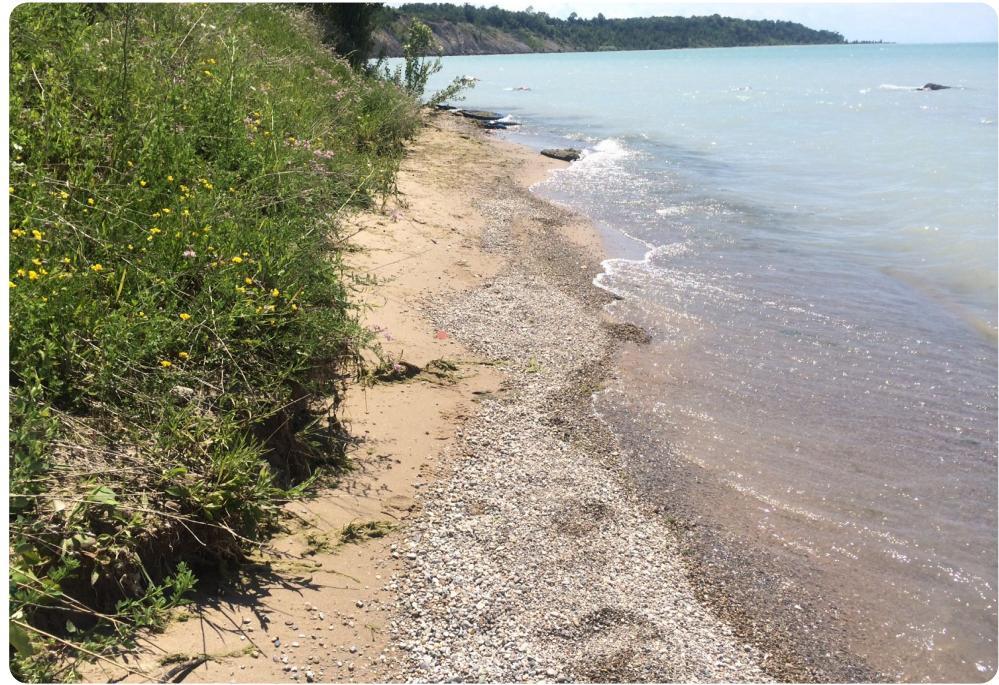
Source: modified from LHCCC

Narrow beaches are insufficient to prevent waves from reaching the base of the bluff.

Beaches that are less than 20 metres wide with no natural protection such as boulders or ice cover during the winter, may be insufficient to prevent wave energy from reaching the base of the bluff, causing erosion. Extremely narrow beaches offer little protection to the bluff from wave impacts and erosion.

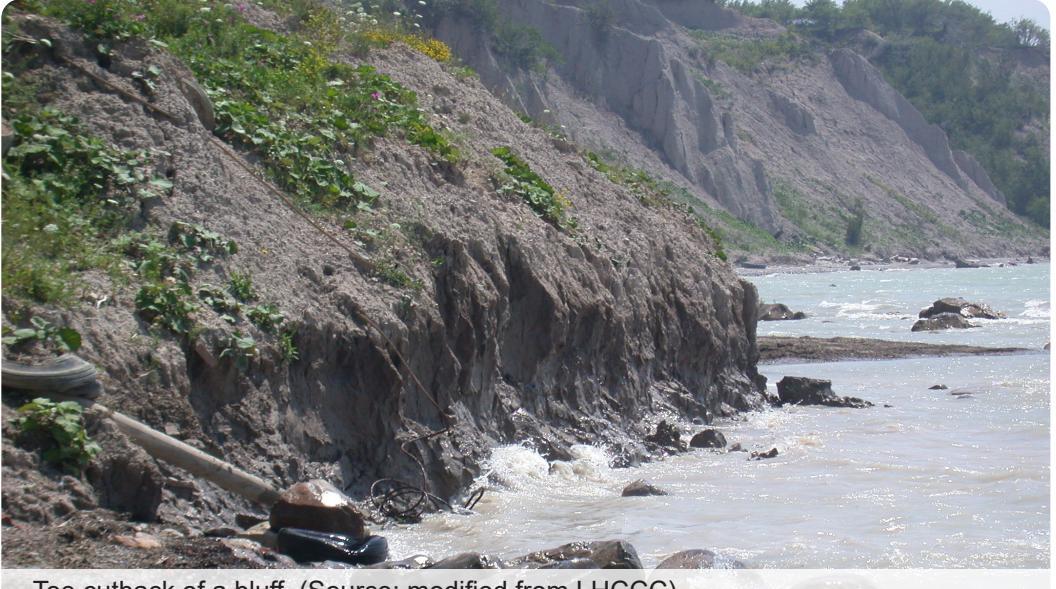
Continuous wave action undercuts the bluff and steepens the slope over time.

Toe cutback of a bluff. (Source: modified from LHCCC).

The continuous action of waves hitting the toe of the bluff causes the removal of sediments. This undercutting increases over time, oversteepening the slope and making the bluff unstable, until a point when the bluff no longer has the strength nor resistance and fails.

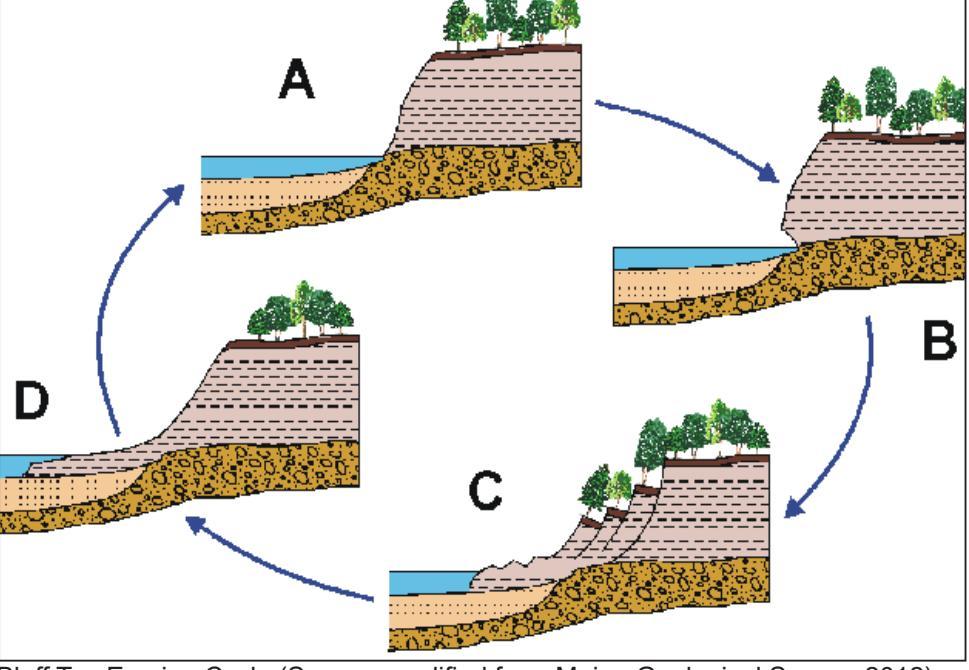
This is an ongoing cycle and therefore, toe erosion is one of the most important indicators to detect high-risk areas. As lake levels rise and fall, waves erode the base of coastal bluffs (A). Over time, this erosion removes material from the base of a bluff and steepens the face (B). The coastal bluff starts to destabilize, as ground water further removes materials, and the bluff fails (C). The material eventually slumps and holds the bluff in place with a gentler profile (D). This cycle will repeat as erosion continues to cut into the base of coastal bluffs.

When sediments are removed, the bluff is no longer in equilibrium.

Bluff Toe Erosion Cycle (Source: modified from Maine Geological Survey, 2012)

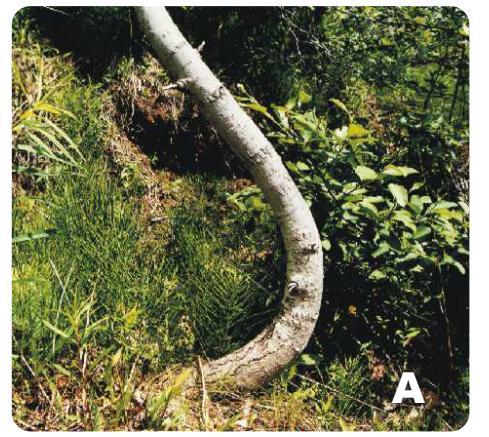
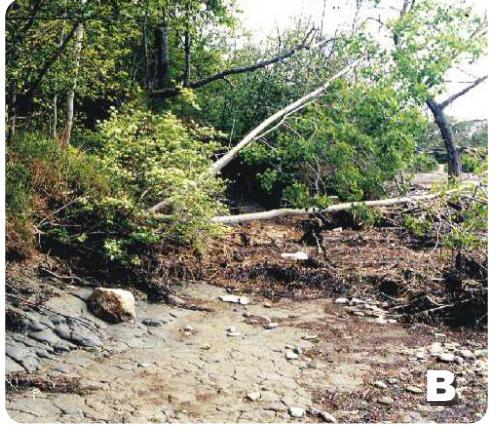
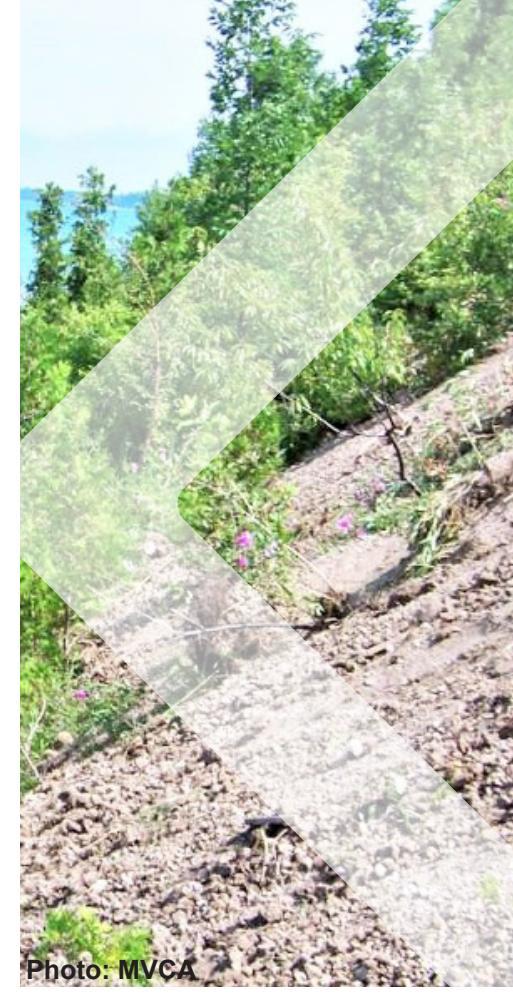
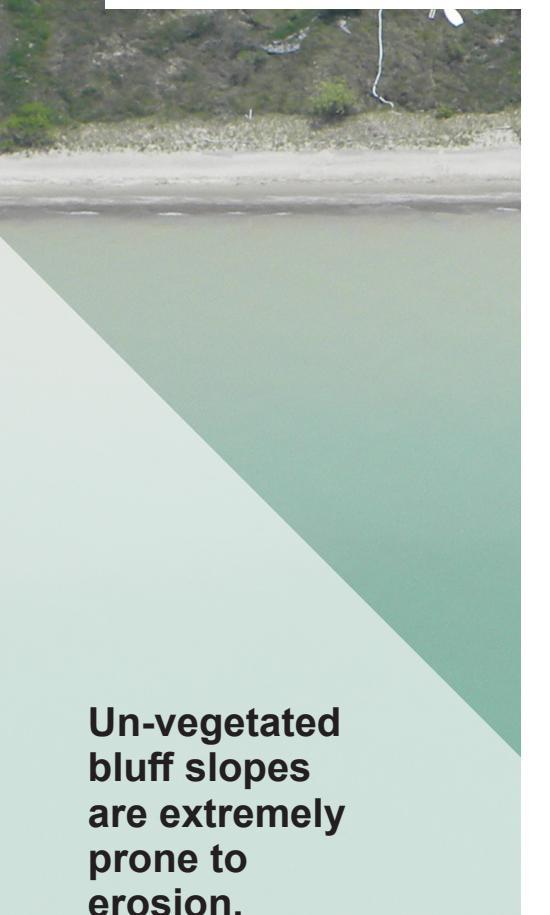
Source: Maine Geological Survey, 2015

Tree trunks that are curved near the base (A) may signify downslope movement or "soil creep". The trunks curve because the tree continues to grow towards the sun as the downslope movement occurs. Trees on the slope may also become tilted (B) because of toe undercutting of the bluff. This makes the bluff unstable and causes landslides, which tilt the trees towards or away from the lake. These are important indicators of bluff instability.

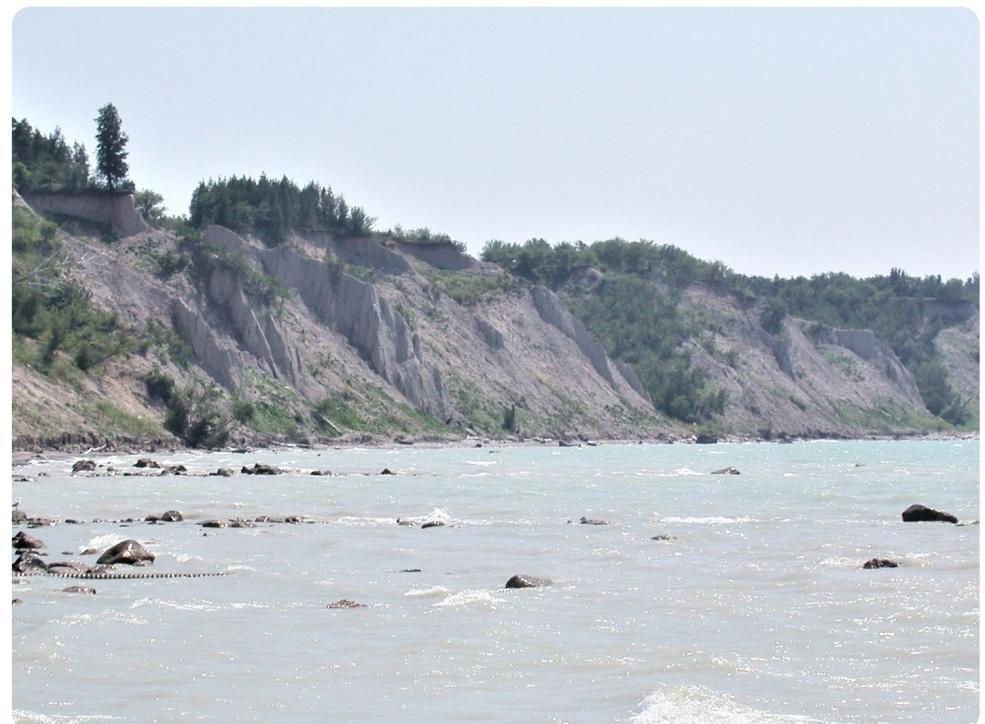
Source: modified from LHCCC

Limited or no vegetation on the slope is a strong indicator of active erosion of the bluff. Without vegetation to hold the soil in place, the slope is prone to wind and water erosion, gullying, mass wasting, slumps, and landslides.

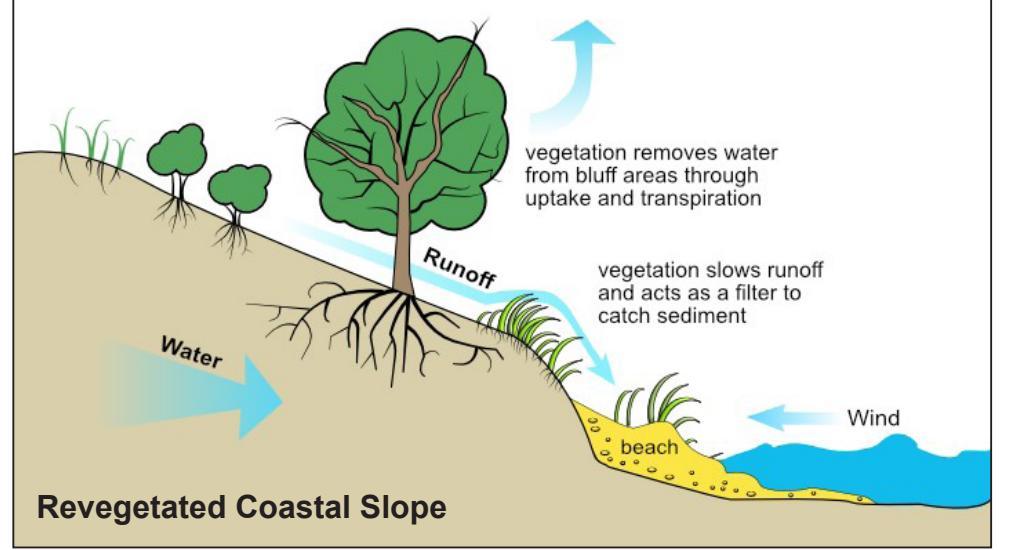
Source: updated for LHCCC - Gullies, n.d.)

Removal of vegetation from the slope of the bluff leads to extensive and rapid erosion of the bluff face. Vegetation should not be cleared as it anchors the soil of the slope, protects the slope from extreme erosion during heavy rainfall, and removes excessive water in the ground through transpiration.

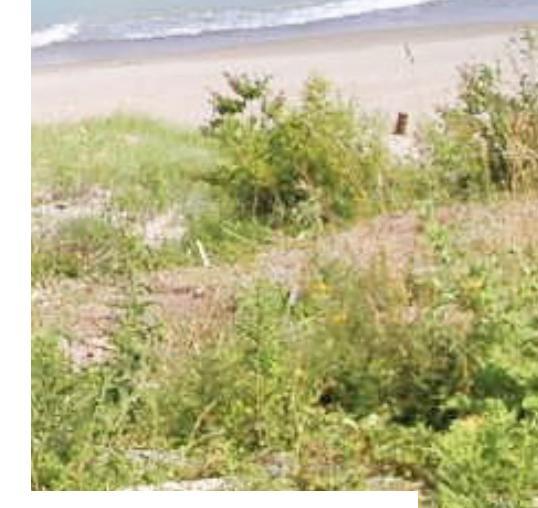
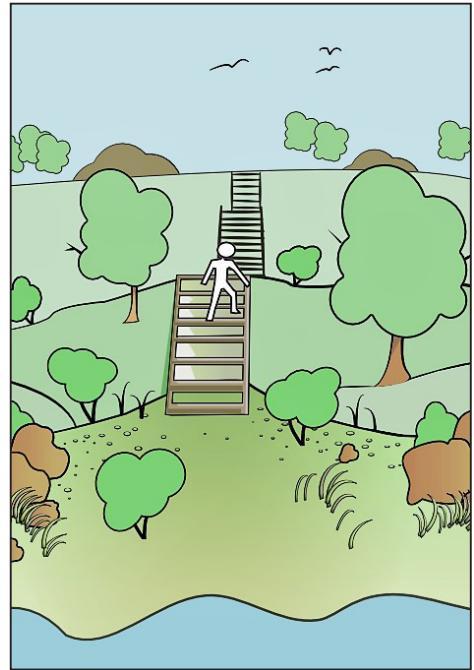
Source: updated for LHCCC - Gullies, n.d.)

Land use is extremely important. Excess water from lawns, paths, and driveways flowing down the bluff, or walkways on the face of the bluff, could rapidly increase the rate of erosion. Additional weight from buildings on the bluff (including pools) may increase the risk of slump/landslide. Bluffs that are stable may become unstable over time because of natural processes and anthropogenic activities.
